PRODUCT BULLETIN

Crossfire[®] and Hurricane[™] Shaft Seal Change

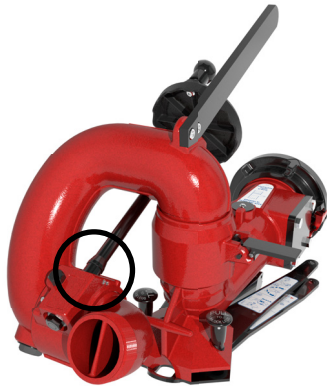
CROSSFIRE MONITOR

A design change has been made to the lower seal on the shaft of all Crossfire monitors, and manually operated Hurricane monitors.

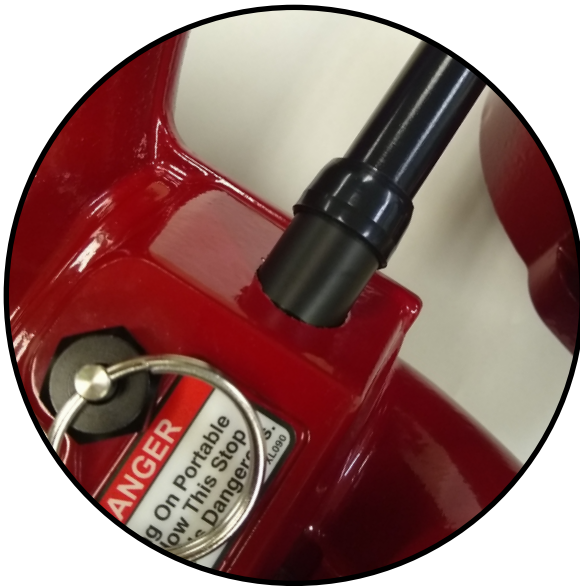
**PREVIOUS DESIGN
THROUGH 9/2021**

The molded external cover boot (TFT part # X240) is replaced with an internal O-ring.
