PRODUCT BULLETIN

3" Monitor Flange Connection Change

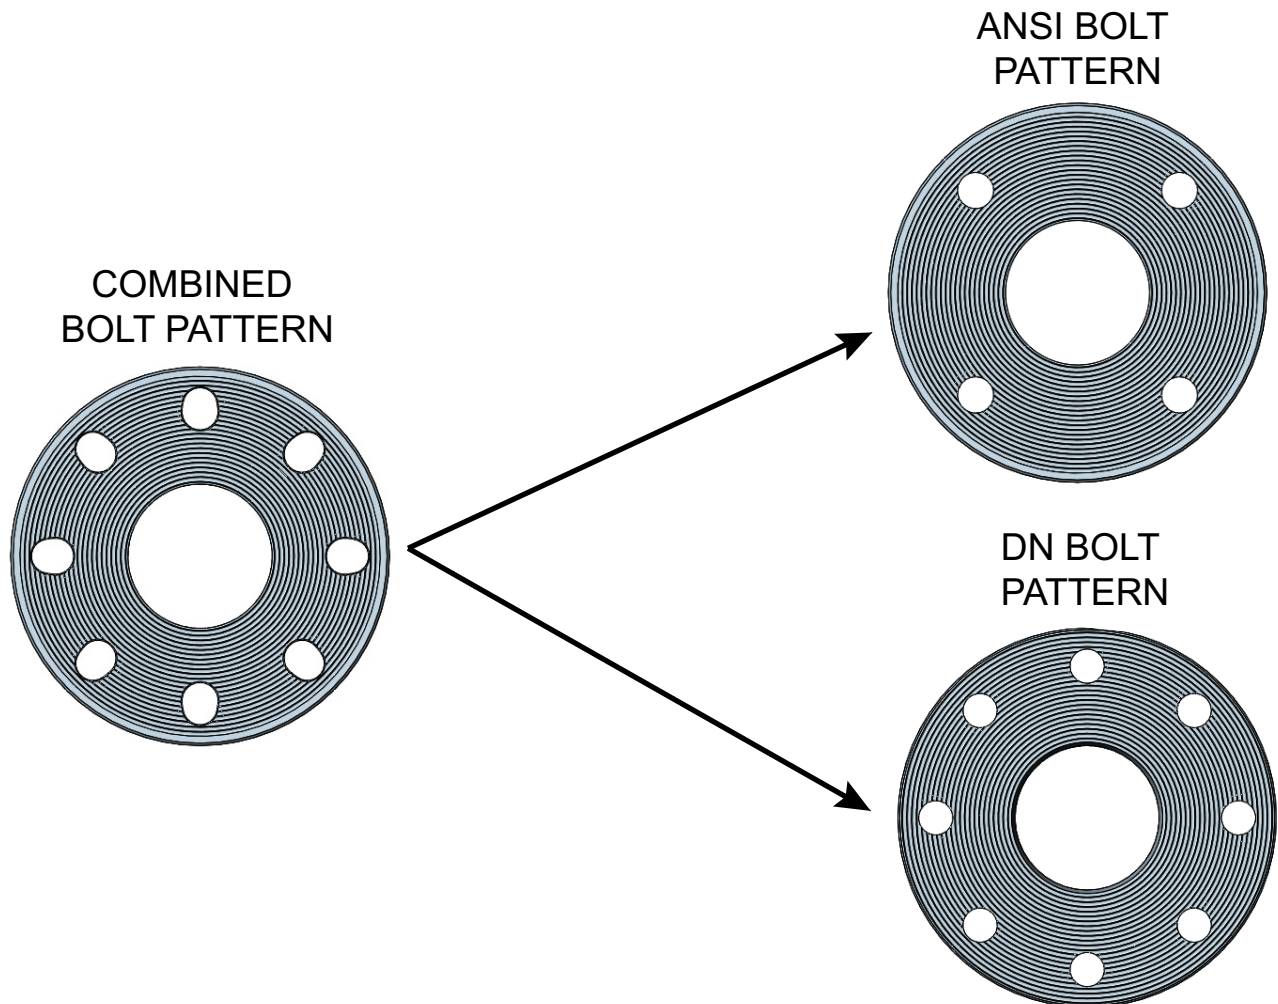
CURRENT DESIGN
Through 10/31/2022

UPDATED DESIGN
Beginning 11/1/2022

In response to customer feedback regarding the recent change combining the 3" flanges into a single flange with ANSI and DN bolt hole patterns, a design change has been made to separate 3" monitor connection flanges to the original single-pattern configurations.
